New Hampshire Volunteer Lake Assessment Program

2003 Biennial Report for Perkins Pond Sunapee

NHDES
Water Division
Watershed Management Bureau
29 Hazen Drive
Concord, NH 03301

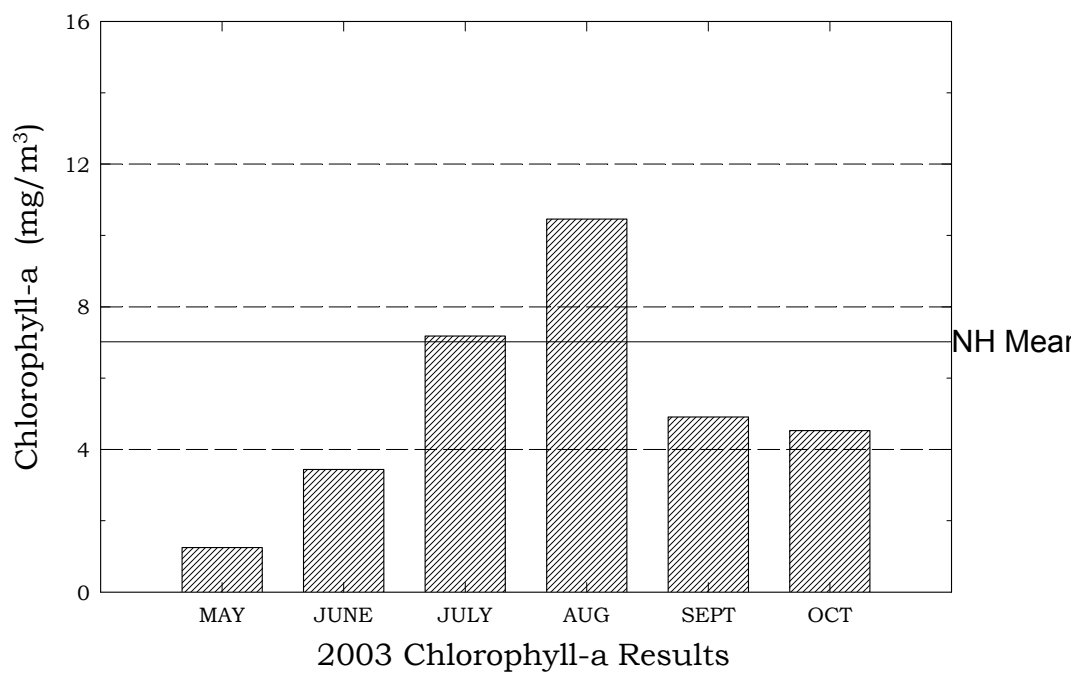
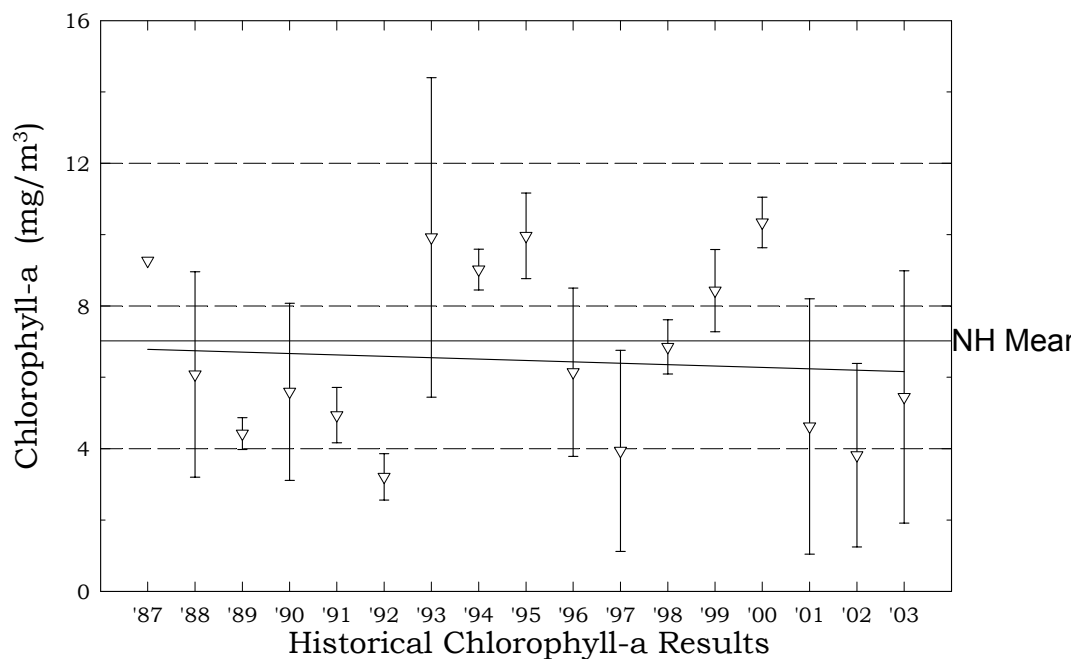
Figure 1. Monthly and Historical Chlorophyll-a Results

- **Figure 1 and Table 1:** The graphs in Figure 1 (Appendix A) show the historical and current year chlorophyll-a concentration in the water column. Table 1 (Appendix B) lists the maximum, minimum, and mean concentration for each sampling season that the lake/pond has been monitored through the program.

The current year data (the top graph) show that the chlorophyll-a concentration **increased consistently** from May to August, **decreased greatly** from August to September, and then **decreased slightly** from September to October. The chlorophyll-a concentration in May, June, September, and October was **much less than** the state mean. The chlorophyll-a concentration July was **slightly greater than** the state mean, and in August (10.46 ug/L) it was **greater than** the state mean.

The historical data (the bottom graph) show that the 2003 chlorophyll-a mean is **less than** the state mean.

Overall, the statistical analysis of the historical data (the bottom graph) shows that the mean annual chlorophyll-a concentration has **not significantly changed** since monitoring began in **1987**. Specifically, the chlorophyll-a concentration has **fluctuated** (but has not *continually increased* or *continually decreased*) since monitoring began. (Note: Please refer to Appendix E for the detailed statistical analysis explanation and data print out.)

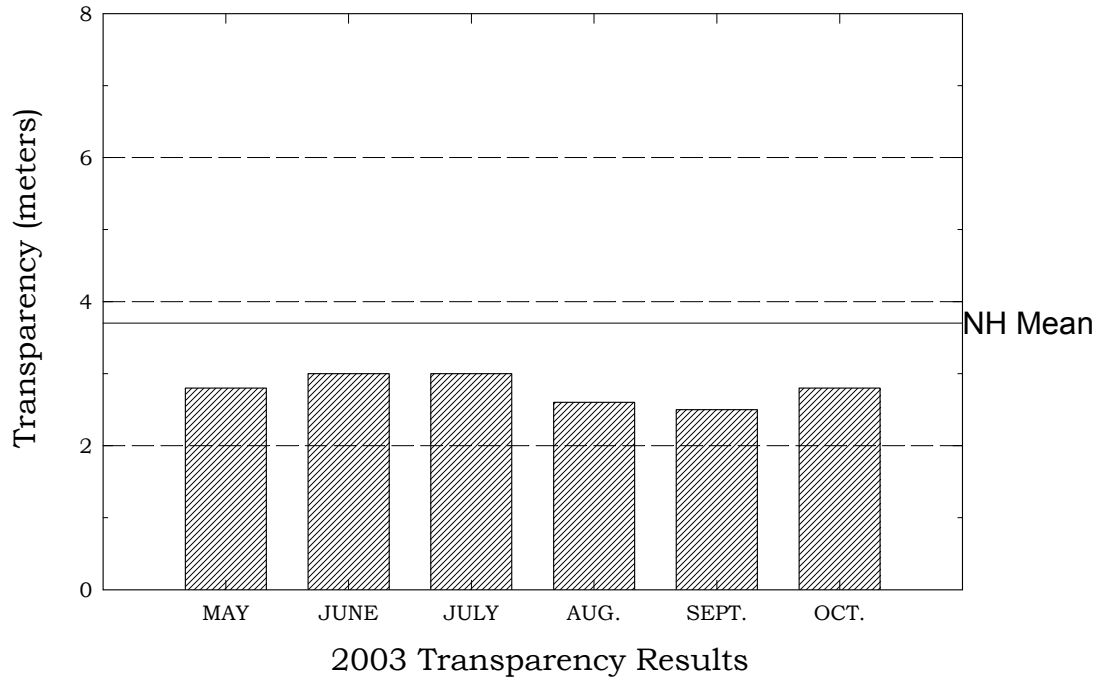
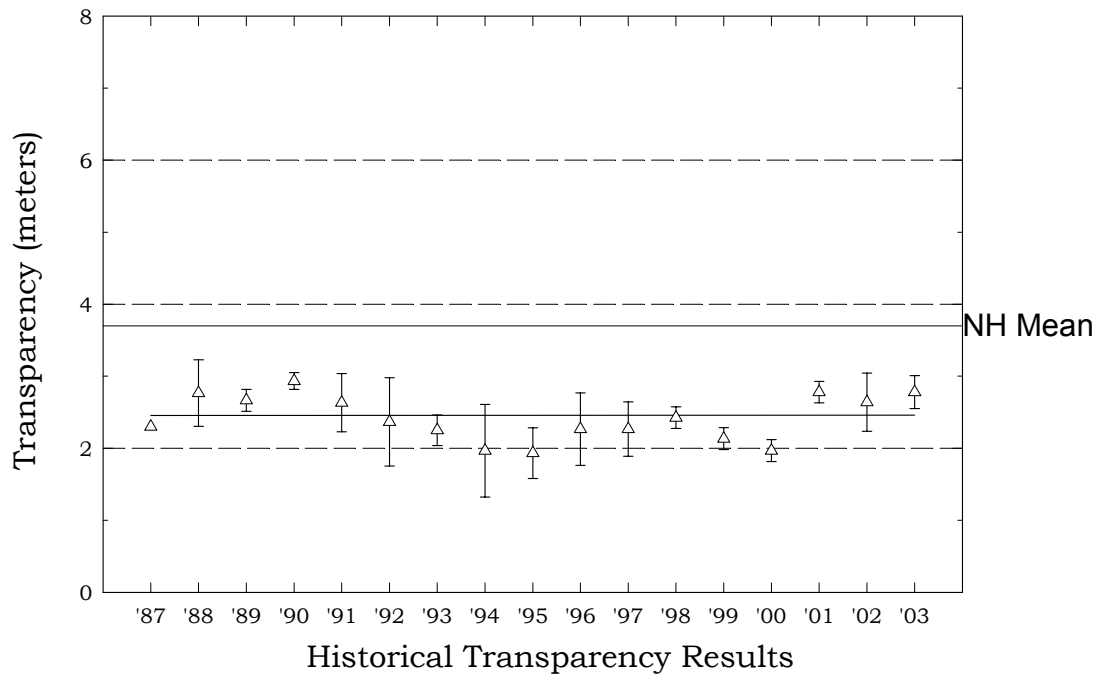
Figure 2. Monthly and Historical Transparency Results

- **Figure 2 and Table 3:** The graphs in Figure 2 (Appendix A) show historical and current year data for lake/pond transparency. Table 3 (Appendix B) lists the maximum, minimum and mean transparency data for each sampling season that the lake/pond has been monitored through the program.

The current year data (the top graph) show that the in-lake transparency **remained relatively stable** from May to October.

Overall, the statistical analysis of the historical data (the bottom graph) show that the mean annual in-lake transparency has **not significantly changed** (either *increased* or *decreased*) since monitoring began in **1987**. Specifically, the in-lake transparency has **remained between approximately 2 and 3 meters** since monitoring began. (Note: Please refer to Appendix E for the statistical analysis explanation and data print out.)

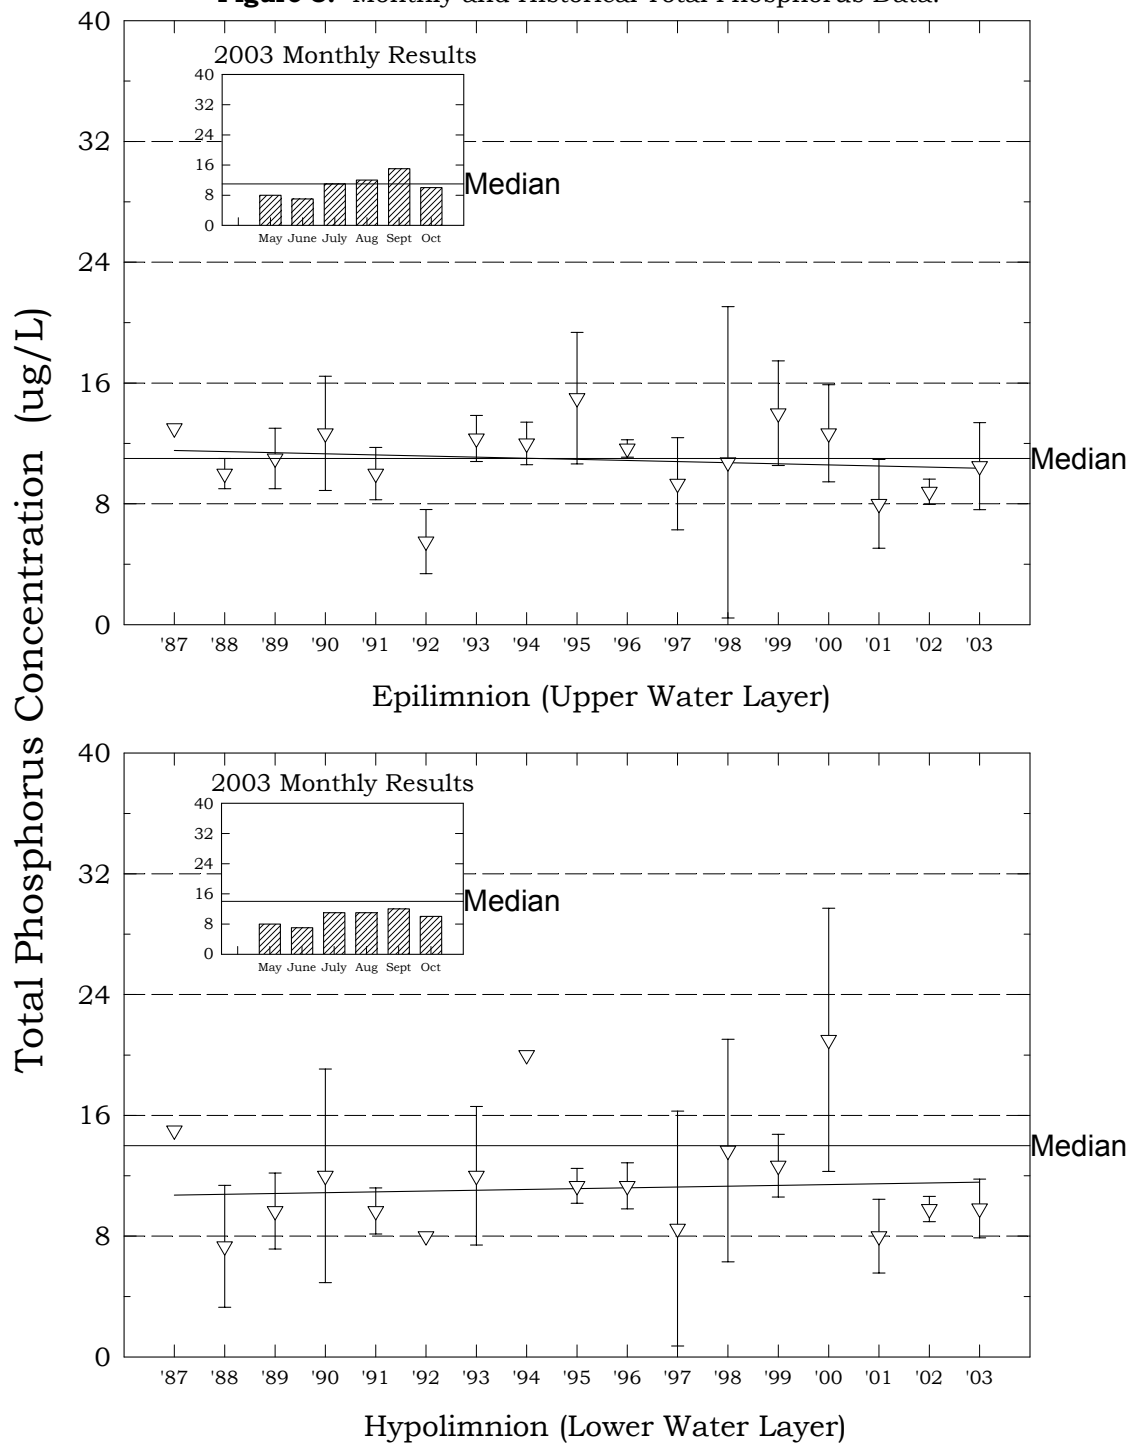
Figure 3. Monthly and Historical Total Phosphorus Data.

- **Figure 3 and Table 8:** The graphs in Figure 3 (Appendix A) show the amounts of phosphorus in the epilimnion (the upper layer) and the hypolimnion (the lower layer); the inset graphs show current year data. Table 8 (Appendix B) lists the annual maximum, minimum, and median concentration for each deep spot layer and each tributary since the lake/pond has joined the program.

The current year data for the epilimnion (the top inset graph) show that the phosphorus concentration **decreased very slightly** from May to June, **increased consistently** from June to September, and then **decreased** from September to October. The phosphorus concentration in August and September was **greater than** the state median.

The historical data show that the 2003 mean epilimnetic phosphorus concentration is **approximately equal to** the state median.

The current year data for the hypolimnion (the bottom inset graph) show that the phosphorus concentration **decreased very slightly** from May to June, **increased** from June to July, and then **remained stable** from July to October. The phosphorus concentration on each sampling event was **less than** the state median.

Overall, the statistical analysis of the historical data show that the phosphorus concentration in the epilimnion (upper layer) and the hypolimnion (lower layer) has fluctuated, but has **not significantly changed** (either *continually increased* or *continually decreased*) since monitoring began in **1987**. (Note: Please refer to Appendix E for the statistical analysis explanation and data print out.)
